Safe Air at Home

Many home performance contractors think indoor air quality (IAQ) problems result from pollutants in the house that are too concentrated, due to inadequate ventilation. This is correct thinking but not a complete picture. At my home performance company, Pure Energy, we are finding more and more IAQ problems caused by pollutants that are supposed to be *outside* the living space, but are being drawn *into* the living space by unbalanced house pressures. Home performance contractors should fix these imbalances whenever possible. To do so requires proper diagnostic testing and a solid understanding of how occupants control their energy and how a house, and everything in it, acts as a system. This is a story about one recent home performance job that didn't go very well.

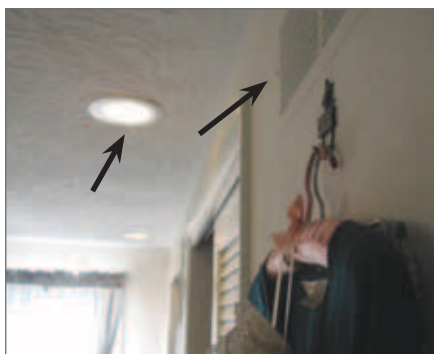
The home had recessed lights near the return.

The recessed lights were covered and packed with fiberglass. They were not air sealed at the ceiling or over the lights; they were not insulation contact (IC) rated, and they were not protected properly from overheating.

The home performance contractor returned to seal and dam the recessed lights, and fix the furnace filter slot so the filter actually performed. About a week after the fixes, the woman reported that she was feeling better, but not 100% better. We asked if we could return to do diagnostic tests and asked her to leave while we did our testing, so the air

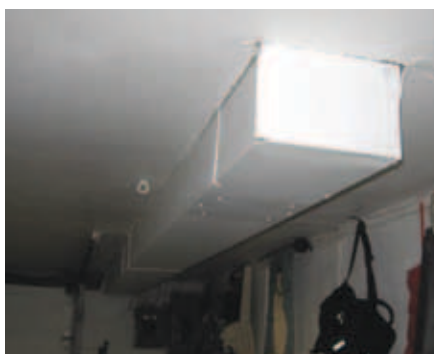
Garage ductwork in the home.

movement and air changes caused by the blower door would not exacerbate her problems. When we did our diagnostic tests, we found that the return ducts in the garage (outside the thermal boundary) were leaky, sucking garage air into the living space.

room. Now we confirmed that the leaky ductwork from the garage brought bad air into the breathing space. This was happening because the blocked return registers were causing higher suction pressure in the leaky garage ducts. When the woman closed off the supply registers, she caused the house to be under higher negative pressure with reference to the outside. Therefore, the makeup air from the unbalanced system came from the garage and the attic through the unsealed recessed lights and attic hatch. When she closed off the return registers, she caused those rooms to be under higher positive pressure, pushing warm and moist air into the attic. This in turn caused moisture to condense and create wet cellulose, frost, and mold.

Since the contractor had returned to seal the leaky recessed lights, what was left to seal was the leaky garage ductwork. We asked the contractor to do this, but the program administrator refused to pay for it, so the ducts are probably still leaky.

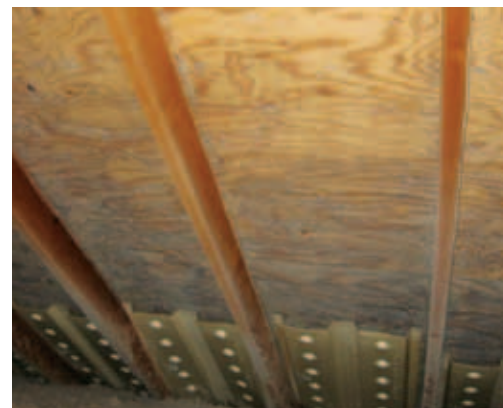
This photo shows the frost and evidence of the mold on the roof deck.

- The furnace fan ran constantly, even when the fan switch on the thermostat was in the auto position.
- The return air was bypassing the furnace filter, which was poorly installed.
- There were air fresheners in the basement rooms.
- The new cellulose in the attic was damp around the attic hatch, and there was condensation on the roof over the hatch. There was frost and what appeared to be mold on the roof deck near the eaves.
- The relative humidity (RH) in the problem rooms was low.

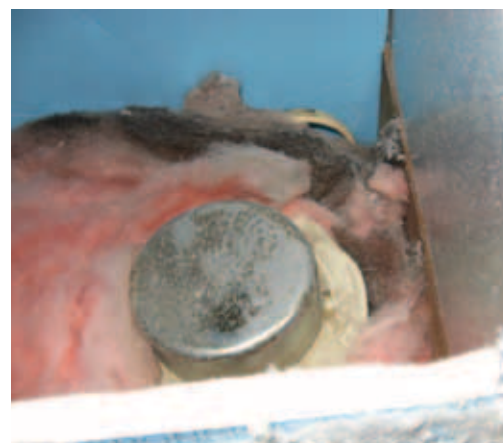
Fiberglass insulation is shown around an unsealed, dammed recessed light.

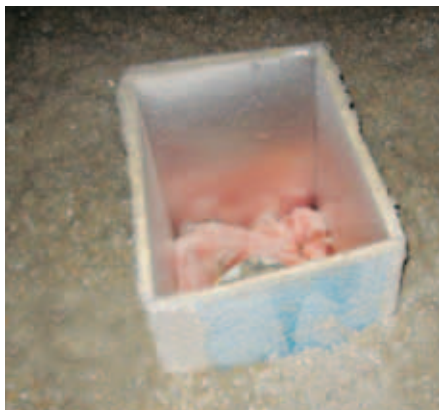
The fiberglass is shown around an unsealed, dammed non-IC recessed light.
